**Proposed Traffic Management Phase 1  
A9 Tomatin South Diversion  
A9 Dualling – Tomatin to Moy  
Scottish Highlands**

Stage 3 Road Safety Audit

Report No. A9P12-DBA-TTM-ZZZZZ-RP-XX-00008(3)

Date: 6<sup>th</sup> March 2026

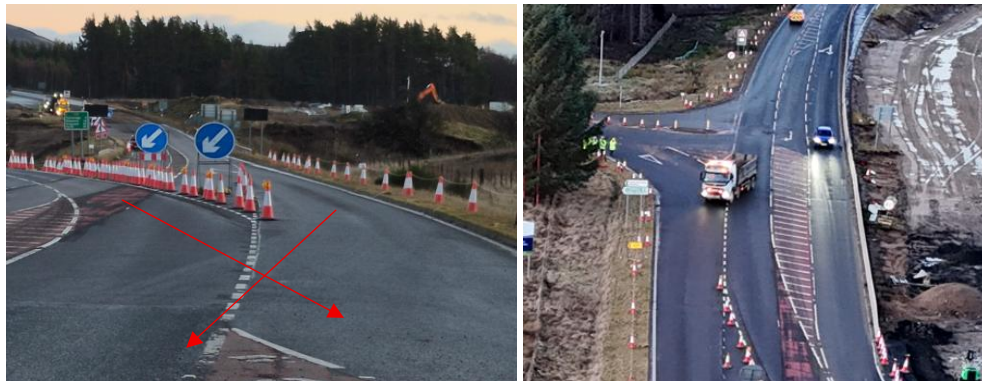
Figure 1: Works Access Exit.

**2.11 PROBLEM**

Location: Works Access/ Exits.

Summary: Insufficient signing and unsafe use of works access/ exit.

During the site visit a number of HGVs were observed entering the works area from the north and turning right across the southbound traffic in a potentially unsafe manoeuvre. In addition to this, there are further risks with this arrangement and with the Tomatin Junction still being open as works vehicles exiting are at risk of colliding with traffic turning left at the Tomatin junction. There is a further risk if an entering vehicle meets an existing vehicle.

It is recommended that that access is taken from the minor road only and the works accesses directly onto the A9 are closed off at this location. In closing off the exit to the north, it is recommended that the keep left arrow is moved further over to the north and west.

The Tomatin junction has been closed and the works access removed. This Problem is closed.

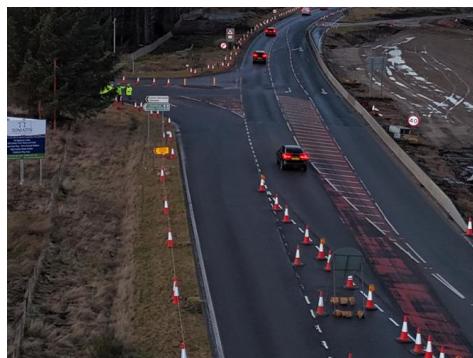
Figure 2: Works Exit Signage

### 2.12 PROBLEM

Location: Works Access/ Works Exit and restricted turns.

Summary: Unclear and insufficient signing.

Notwithstanding the recommendation of closure in Problem 3.1, the proposed signing at the works accesses on the design drawings has additional signage that has not been provided, including “Give Way” and “Works Exit” signage. This was not provided. In addition to this, no signing was provided to restrict right turns or “No-Entry” signage for the northern end of the works.

While it is recommended this be closed as part of the resolution to Problem 3.1, It is recommended that any remaining works access into this (and other sites) have the necessary “Give Way”, “Works Access/ Exit” signage as well as “No Entry” and “No Right Turn” signage.

The works access has been removed. This Problem is closed.

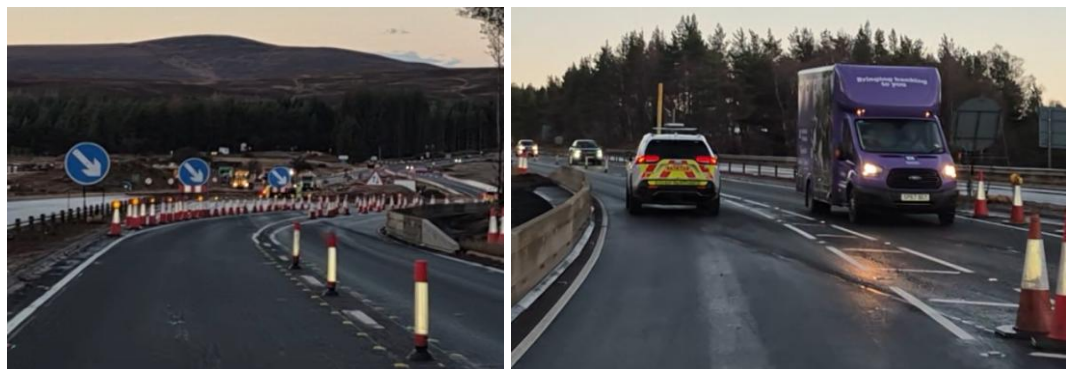
Figure 3: Cone provision.

### 2.13 PROBLEM

Location: Southern tie-in to diversion.

Summary: Gap in cone provision.

At the southern tie-in, there is a gap in separation cones between the cones and the wands. There is a risk that a vehicle could proceed to the wrong side of the cones and collide with an oncoming vehicle.

It is recommended that additional wands/ cones are provided to close this gap.

The layout has been amended to accommodate the new Tomatin junction. This Problem is closed.

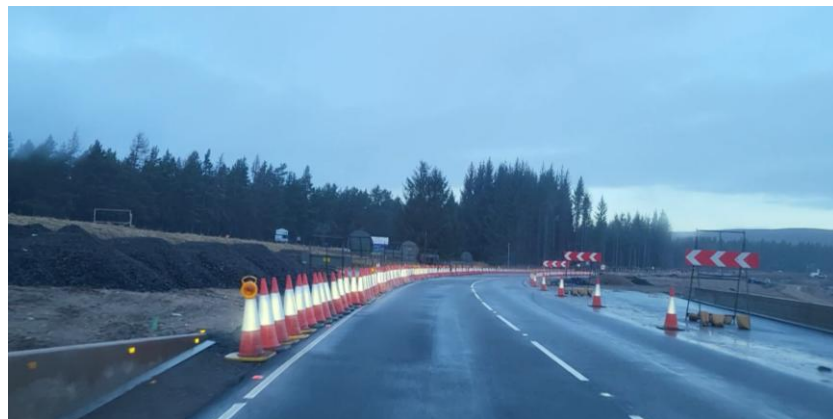
Location: The A9 northbound approach to the closed Tomatin junction.

Summary: Unclear and confusing signing is present.

There are three chevron signs (sharp deviation of route) on the offside of the road, which are usually located at, or in advance of a sharp bend, and in this case are pointing to the left. As they are positioned adjacent to a slow right-hand bend, they could confuse motorists, who could brake or manoeuvre suddenly, with the attendant risk of a number of collision types.

Photo 1: Chevron signs

It is recommended that the signs are removed.

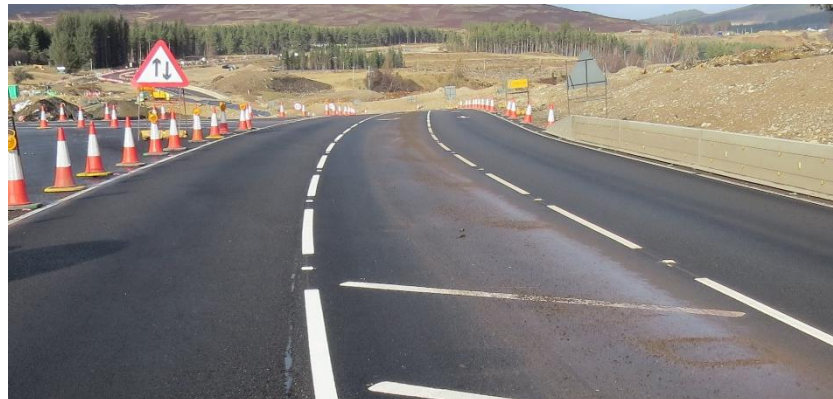
Location: The new Tomatin junction off the A9.

Summary: Extending the hatched markings could reduce the risk of collisions.

The right-turn lane extends as an open lane past the junction. Hatching the lane after the turn point could reduce the risks of northbound motorists mistaking the lane as an overtaking opportunity and of motorists turning right towards Tomatin making excessive forward overturns.

Photo 2: Hatching missing from lane past the junction

It is recommended that the lane is hatched after the turn point.

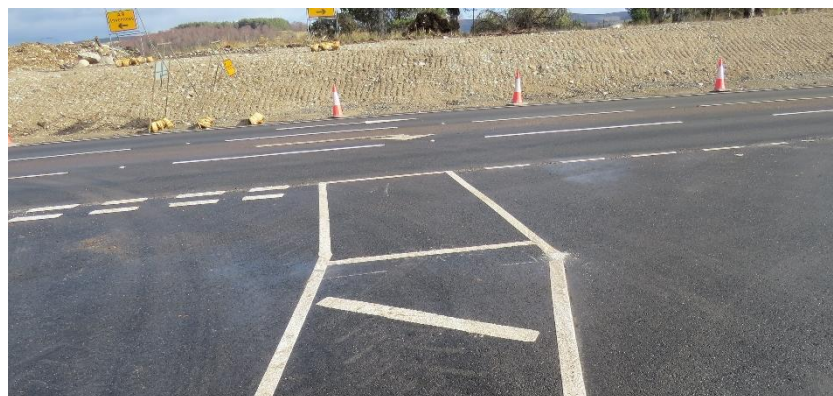
Location: The new Tomatin junction off the A9.

Summary: Extending the hatched markings could reduce the risk of overrunning the centreline.

There is an edge line (box) separation island at the end of the centre hatching in the side road, specified on the drawings to allow for cones and signage. Hatching it could reduce the risk of motorists turning right into the side road over the markings and thus of side swipe collisions with vehicles waiting to turn right out of the junction. It should be noted that the position of the right-turn arrow, which is just far enough forward in the lane, could also encourage tight right turns.

Photo 3: Marked separation island at the junction

It is recommended that the separation island is hatched.
