**Proposed Traffic Management Phase 1  
A9 Tomatin South Diversion  
A9 Dualling – Tomatin to Moy  
Scottish Highlands**

Stage 3 Road Safety Audit

Report No. A9P12-DBA-TTM-ZZZZZ-RP-XX-00008(3)

Date: 6<sup>th</sup> March 2026

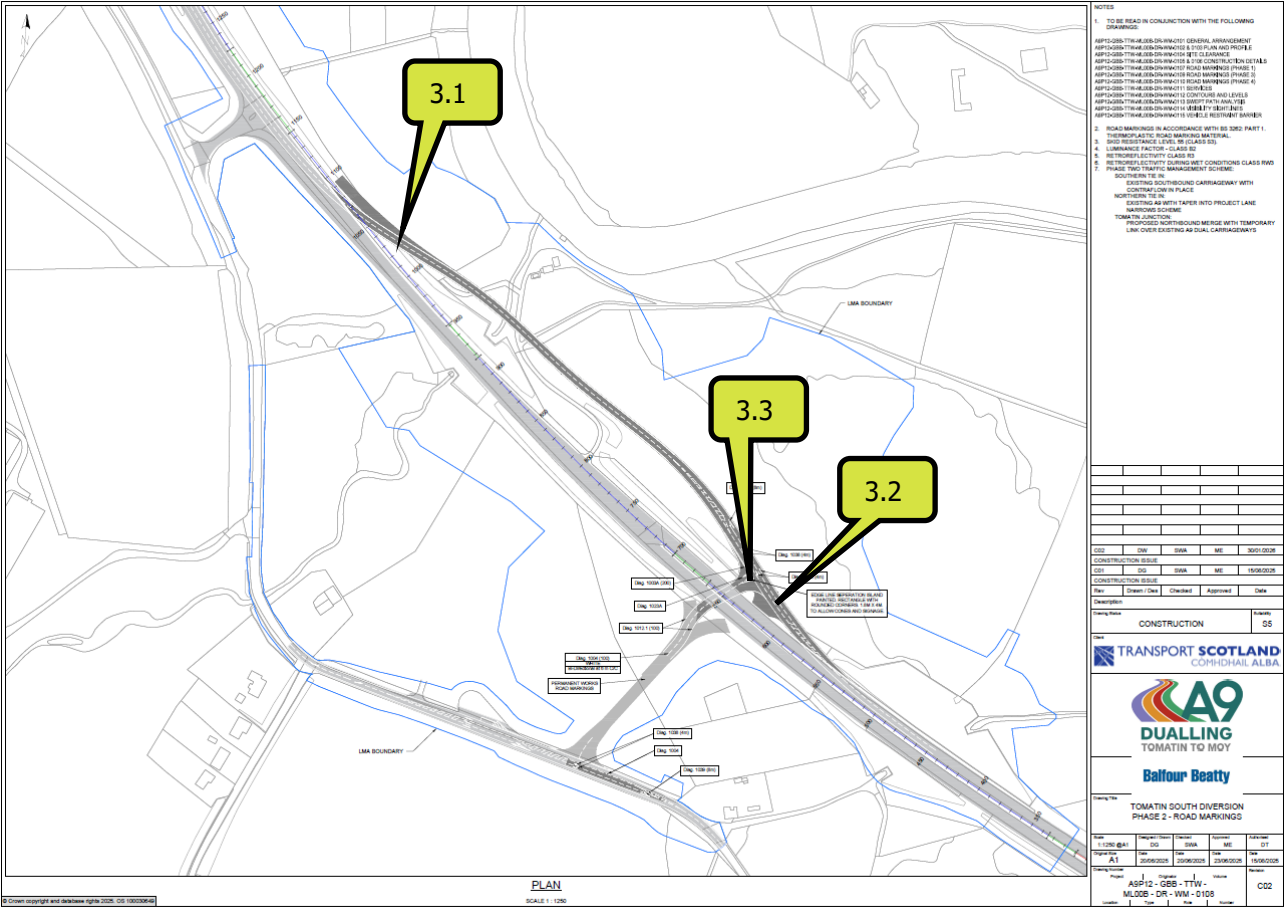
**Appendix B – Location plan of problems identified**

Summary: Insufficient signing and unsafe use of works access/ exit.

During the site visit a number of HGVs were observed entering the works area from the north and turning right across the southbound traffic in a potentially unsafe manoeuvre. In addition to this, there are further risks with this arrangement and with the Tomatin Junction still being open as works vehicles exiting are at risk of colliding with traffic turning left at the Tomatin junction. There is a further risk if an entering vehicle meets an existing vehicle.

Notwithstanding the recommendation of closure in Problem 3.1, the proposed signing at the works accesses on the design drawings has additional signage that has not been provided, including “Give Way” and “Works Exit” signage. This was not provided. In addition to this, no signing was provided to restrict right turns or “No-Entry” signage for the northern end of the works.

It is recommended that that access is taken from the minor road only and the works accesses directly onto the A9 are closed off at this location. In closing off the exit to the north, it is recommended that the keep left arrow is moved further over to the north and west.

While it is recommended this be closed as part of the resolution to Problem 3.1, It is recommended that any remaining works access into this (and other sites) have the necessary “Give Way”, “Works Access/ Exit” signage as well as “No Entry” and “No Right Turn” signage.

It is recommended that additional wands/ cones are provided to close this gap.

It is recommended that the signs are removed.

It is recommended that the lane is hatched after the turn point.

It is recommended that the separation island is hatched.
